**Cantrice Court COA**  
***Simi Valley, CA***

Report #: 4748-3  
Beginning: January 1, 2026  
Expires: December 31, 2026

**RESERVE STUDY**  
**Update "With-Site-Visit"**

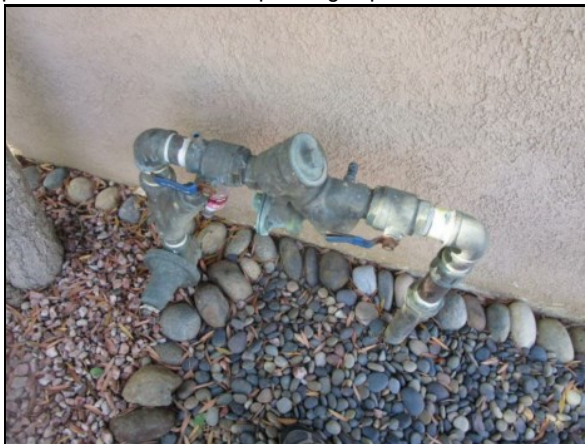
**Comp #: 1001 Backflow Preventers - Replace**

**Comments:** The backflow devices were not tested as part of the scope of this reserve study. Backflow preventer devices are designed to prevent water from backwashing into the drinking water supply. This backwashing water may have been exposed to chemical or soil pollution in the line beyond this valve. Backflow preventer devices should be inspected annually by a licensed plumber. Repairs should be completed as needed as an Operating expense.

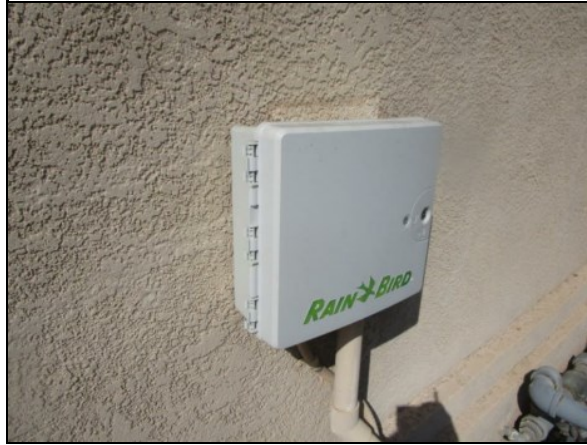
**Comp #: 1003 Irrigation Controllers - Replace**

**Comments:** The irrigation controllers vary in age and brand. No reported issues. Funding to eventually replace with "smart-controllers" for water efficiency.

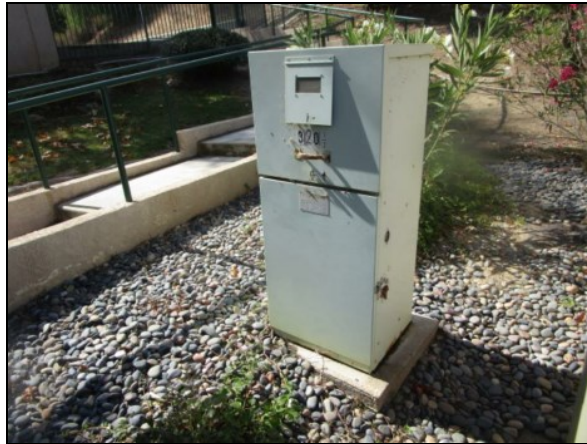
**Comp #: 1006 Electrical Pedestals - Replace**

**Comments:** The utility pedestal houses the electrical meter and electrical breaker panel. We will continue to fund for stainless steel utility pedestals, which are more durable and attractive than galvanized metal models.

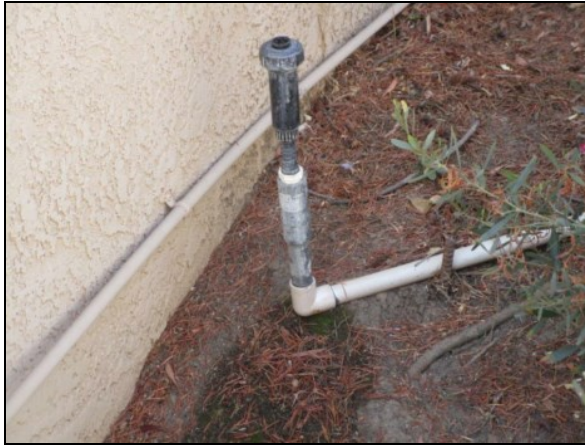
**Comments:** The common area landscaping and irrigation system is maintained on a regular basis as an Operating expense. This line-item provides Reserve funding for periodic partial replacement projects, such as the installation of dry-scape and drip irrigation. There is no expectation for complete replacement at this time.

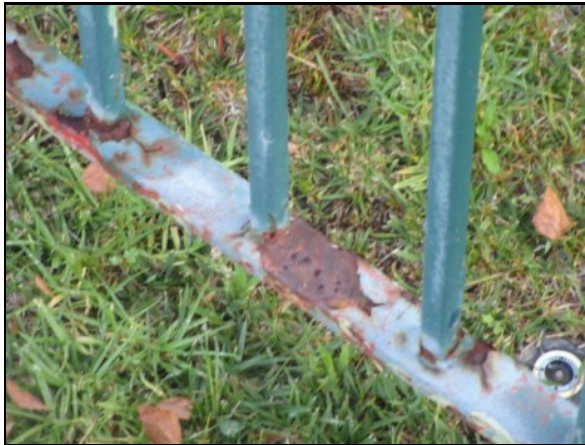
**Comments:** Signs of heavy corrosion and peeling throughout. Metal surfaces should be repainted at least every 5 years in mild climates, and every 2-3 years at beachfront and alpine climates. Regular repainting projects will protect the metal surfaces from damaging weather elements, maintain an attractive appearance, and extend the useful life of the asset. Metal repainting projects should be coordinated with other repainting projects whenever possible, such as stucco and wood.

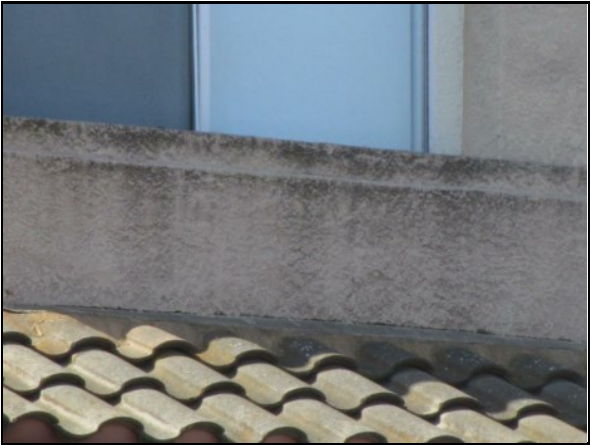
**Comments:** Sections of heavy staining observed. Although not ideal conditions, this project has been extended to prioritize the roof replacement projects. Stucco repainting is for mostly cosmetic purposes.

Funding for periodic repainting projects to maintain an attractive exterior appearance. Stucco repairs should be included as part of each repainting project. In general, stucco should be repainted every 10-20 years. This project should be coordinated with other surfaces (wood & metal) whenever possible to lower the overall cost of repainting. The cost of scaffolding has been added to the cost projections if necessary.

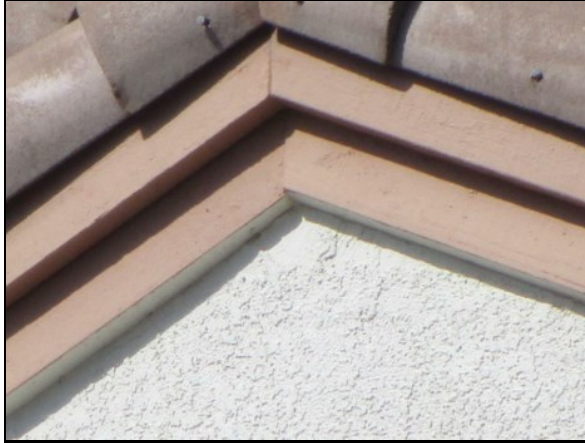
Exterior wood surfaces should be repainted on a regular basis in order to protect the surfaces from damaging weather elements and termite infestation. Wood surfaces should be repainted every 4-6 years in mild climates, and every 2-3 in beach or alpine climates. Repainting on schedule will decrease ongoing wood repair costs dramatically, while maintaining attractive exterior appearances. The repainting of the wood surfaces should be coordinated with other surfaces, such as stucco and metal, whenever possible to lower the overall cost of repainting and to utilize the same scaffolding at certain projects.

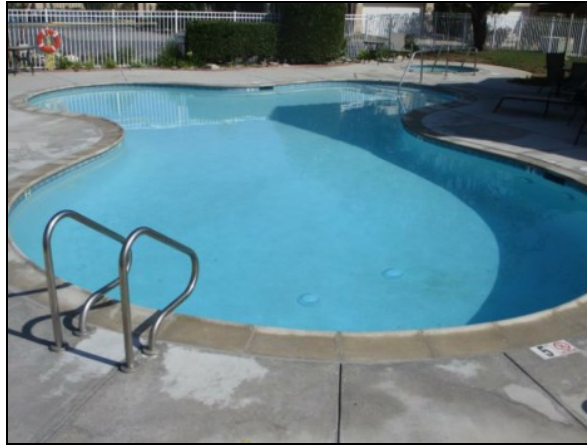
**Comments:** Plaster is showing signs of minor surface wear and discoloration. Tiles are intact. Fair condition. Funding for the replastering of the pool surfaces every 10-15 years, and the replacement of the tile at longer intervals. Project may also include the replacement of ladder and handrail.

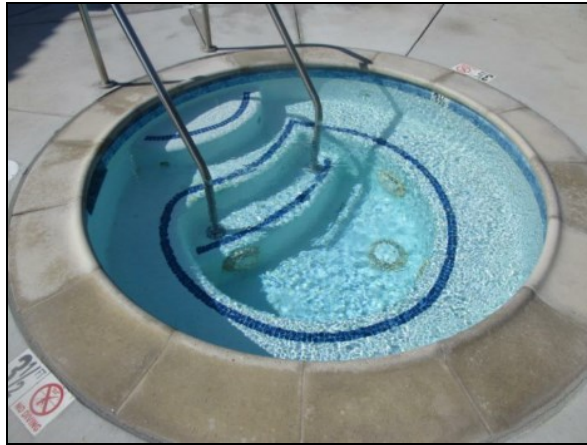
**Comments:** Plaster is showing signs of minor surface wear and discoloration. Tiles are intact. Fair condition. Funding for the replastering of the pool surfaces every 10-15 years, and the replacement of the tile at longer intervals. Projects may include the replacement of the (2) handrails.

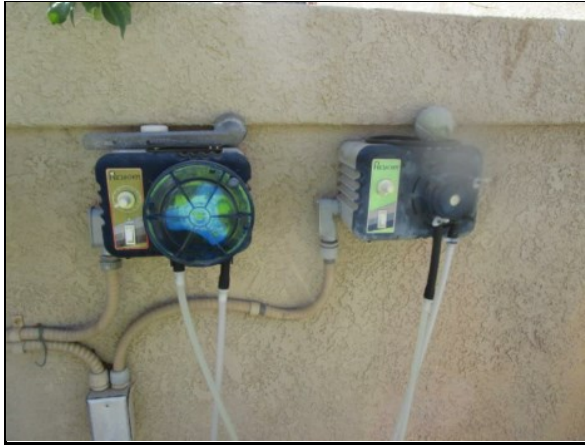
**Comp #: 1209 Pool/Spa Chemical Pumps - Replace**

**Comments:** No reported issues with the chemical pump. Assumed to be in good working order. These pumps should be monitored closely by your pool service professional to ensure safe water chemistry. Improper water chemistry can lead to shorter lifespans of the pool plaster, heaters and filters.

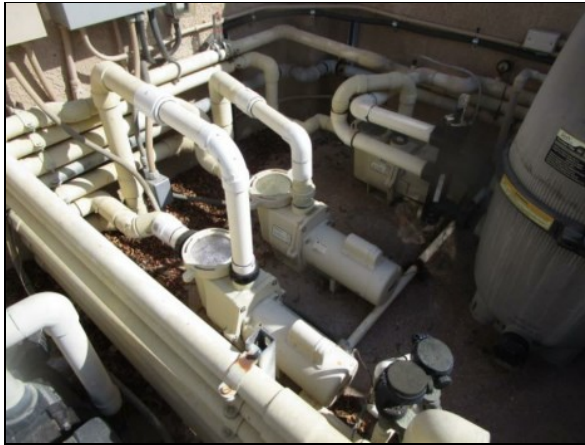
**Comp #: 1210 Pool/Spa Pumps - Partial Replace**

**Comments:** The pumps vary in age. There is no expectation to replace all pumps at the same time. Funding for ongoing replacements of individual pumps as they fail. The pumps should be serviced on a regular basis as an Operating expense. The cost to replace individual pump motors is too low for Reserve designation. Replace motors as needed as an Operating expense. Funding for the replacement of the entire pump assembly from Reserves.
